**Flood Control Project Maintenance
Levee Inspections**

Fall 2016 Levee Maintenance Deficiency Summary Report

**Flood Control Project Maintenance
Levee Inspections**
LMA District Cover Sheet
Fall 2016 Levee Inspection Results

Tehama County Flood Control and Water Conservation District

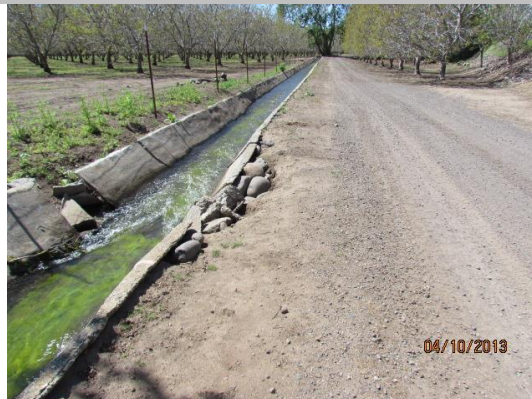
Photo 1 of 1 : FA_2016_NA0019_78_41_20160823_00012.jpg

LM Start	0.00	Rating **	U	Issue No.	41
LM End	0.65	Issue Type +	En	Location *	LS
Category	Earthen Levee			GPS Latitude/Longitude	
				Start	End
Item	Encroachments			39.973077 °	39.971722 °
				-121.980344 °	-121.991869 °
DWR ID	DWR_NA0019_01_s_2016_41				
Comment Code					
DT : Ditch					
Inspector Comment					
Concrete-lined ditch on landside.

View of the concrete-lined ditch along landside.

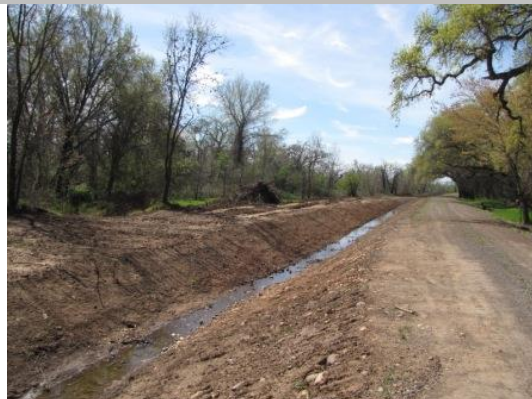
Photo 1 of 1 : FA_2016_NA0019_78_2_20160823_00001.jpg

LM Start	1.79	Rating **	M	Issue No.	2
LM End	2.22	Issue Type +	En	Location *	LS
Category	Earthen Levee			GPS Latitude/Longitude	
				Start	End
Item	Encroachments			39.969443 °	39.966921 °
				-122.012261 °	-122.019469 °
DWR ID	DWR_NA0019_01_s_2012_2				
Comment Code					
DT : Ditch					
Inspector Comment

View of an agricultural ditch along the levee toe.

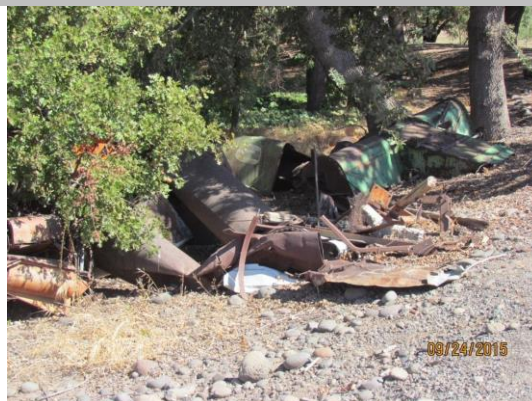
Photo 1 of 1 : FA_2016_NA0019_78_37_20160823_00009.jpg

LM Start	3.06	Rating **	M	Issue No.	37
LM End	3.06	Issue Type +	En	Location *	WS
Category	Earthen Levee			GPS Latitude/Longitude	
				Start	End
Item	Encroachments			39.961798 °	39.961798 °
				-122.032723 °	-122.032723 °
DWR ID	DWR_NA0019_01_f_2015_37				
Comment Code					
EQ : Equipment					
Inspector Comment					
Remove the scrap equipment along the waterside toe.

View of the scrap equipment along the waterside toe.

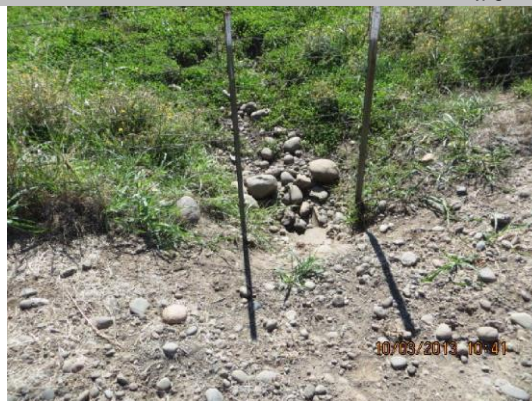
Photo 1 of 2 : UCIP_FA_2016_23094_39307.jpg

LM Start	3.75	Rating **	M	Issue No.	285 (cont)
LM End	3.75	Issue Type +	En	Location *	LS

Concrete pipe at inlet on LS toe.

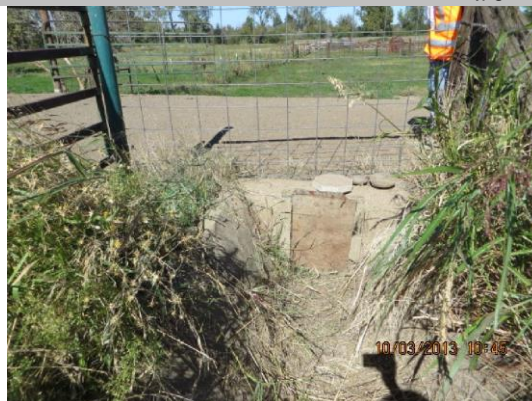
Photo 1 of 2 : UCIP_FA_2016_23092_39298.jpg

LM Start	3.75	Rating **	M	Issue No.	284 (cont)
LM End	3.75	Issue Type +	En	Location *	LS

Slide panel at inlet on LS shoulder.

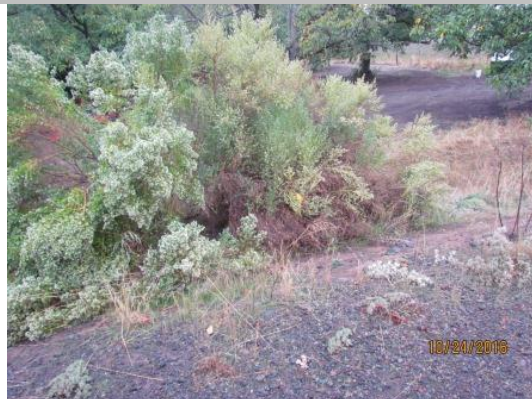
Photo 1 of 1 : FA_2016_NA0019_78_16_20161107_00058.jpg

LM Start	3.75	Rating **	M	Issue No.	16
LM End	3.75	Issue Type +	Ma	Location *	LS
Category	Earthen Levee			GPS Latitude/Longitude	
				Start	End
Item	Vegetation			39.944407 °	39.944407 °
				-122.054104 °	-122.054104 °
DWR ID	DWR_NA0019_01_f _ 2016_16				
Comment Code					
V2 : Remove the wild growth other than native grasses from the levee slopes.					
Inspector Comment

View of a bush obstructing visibility.

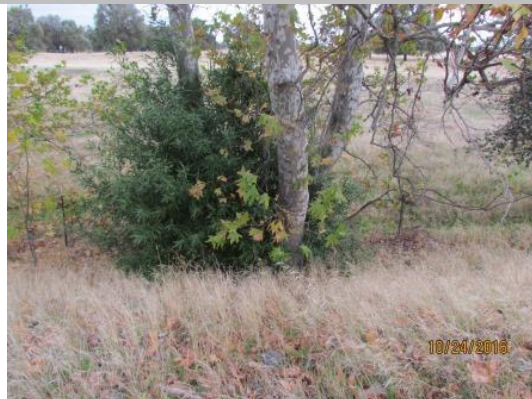
Photo 1 of 1 : FA_2016_NA0019_79_13_20161107_00013.jpg

LM Start	0.23	Rating **	M	Issue No.	13
LM End	0.23	Issue Type +	Ma	Location *	LS
Category	Earthen Levee			GPS Latitude/Longitude	
				Start	End
Item	Trim / Thin Trees			39.970598 °	39.970598 °
				-122.013053 °	-122.013053 °
DWR ID	DWR_NA0019_02_f_2016_13				
Comment Code					
T1 : Trim trees to at least five feet above ground level.					
Inspector Comment

View of a tree with new thick growth blocking visibility.

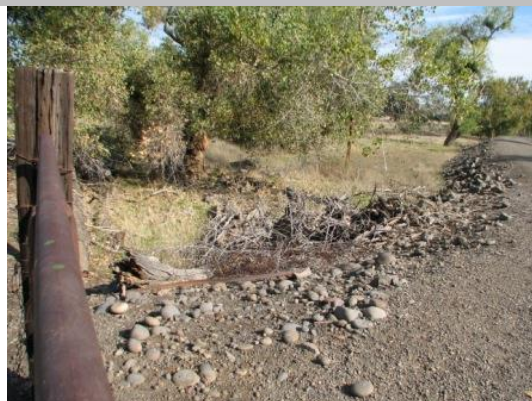
Photo 1 of 1 : FA_2016_NA0019_79_2_20160823_00001.jpg

LM Start	0.30	Rating **	M	Issue No.	2
LM End	0.30	Issue Type +	Ma	Location *	LS
Category	Earthen Levee			GPS Latitude/Longitude	
				Start	End
Item	Encroachments			39.970305 °	39.970305 °
				-122.014465 °	-122.014465 °
DWR ID	DWR_NA0019_02_s_2012_2				
Comment Code					
DE : Debris					
Inspector Comment

View of debris and wire at the toe of levee.

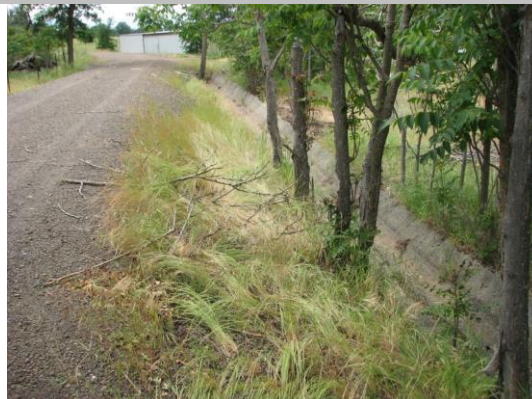
Photo 1 of 1 : FA_2016_NA0019_79_11_20160823_00006.jpg

LM Start	0.32	Rating **	M	Issue No.	11
LM End	0.34	Issue Type +	En	Location *	LS
Category	Earthen Levee			GPS Latitude/Longitude	
				Start	End
Item	Encroachments			39.970193 °	39.970188 °
				-122.014738 °	-122.015034 °
DWR ID	DWR_NA0019_02_s_2016_11				
Comment Code					
DT : Ditch					
Inspector Comment					
Concrete-lined.

View of a concrete-lined ditch along the levee toe.

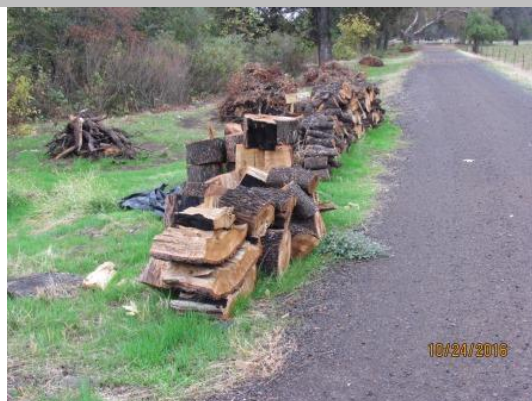
Photo 1 of 1 : FA_2016_NA0019_79_14_20161107_00014.jpg

LM Start	0.35	Rating **	M	Issue No.	14
LM End	0.35	Issue Type +	En	Location *	WS
Category	Earthen Levee			GPS Latitude/Longitude	
				Start	End
Item	Encroachments			39.970153 °	39.970153 °
				-122.015194 °	-122.015194 °
DWR ID	DWR_NA0019_02_f_2016_14				
Comment Code					
FW : Firewood					
Inspector Comment

View of the firewood along the waterside slope.

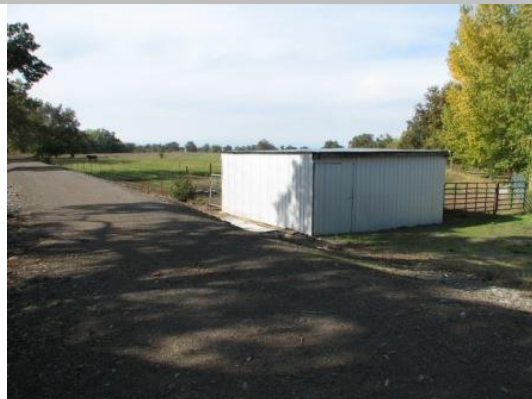
Photo 1 of 1 : FA_2016_NA0019_79_7_20160823_00005.jpg

LM Start	0.35	Rating **	M	Issue No.	7
LM End	0.35	Issue Type +	En	Location *	LS
Category	Earthen Levee			GPS Latitude/Longitude	
				Start	End
Item	Encroachments			39.970117 °	39.970117 °
				-122.015365 °	-122.015365 °
DWR ID	DWR_NA0019_02_s_2012_7				
Comment Code					
BU : Building					
Inspector Comment

View of a building along the levee toe.

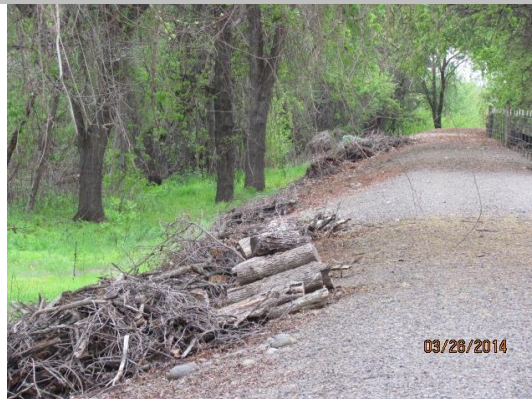
Photo 1 of 1 : FA_2016_NA0019_79_3_20160823_00002.jpg

LM Start	1.37	Rating **	M	Issue No.	3
LM End	1.37	Issue Type +	En	Location *	WS
Category	Earthen Levee			GPS Latitude/Longitude	
				Start	End
Item	Encroachments			39.963997 °	39.963997 °
				-122.032030 °	-122.032030 °
DWR ID	DWR_NA0019_02_f_2013_3				
Comment Code					
DE : Debris					
Inspector Comment

View of the debris along the waterside slope.

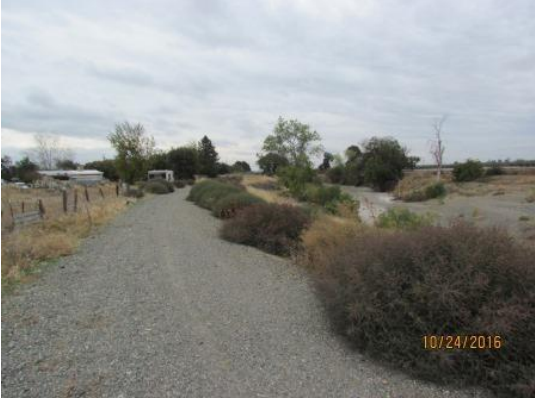
Photo 1 of 1 : FA_2016_NA0019_81_26_20161107_00027.jpg

View of the annual vegetation along the waterside crown and slope.

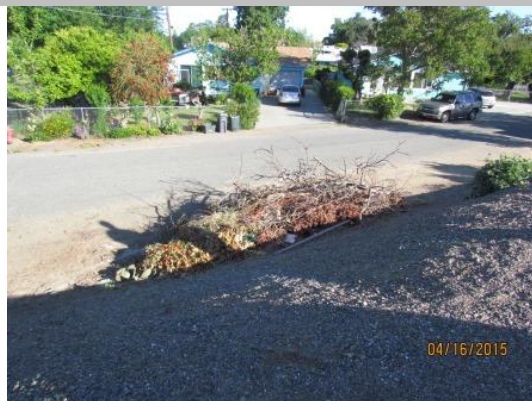
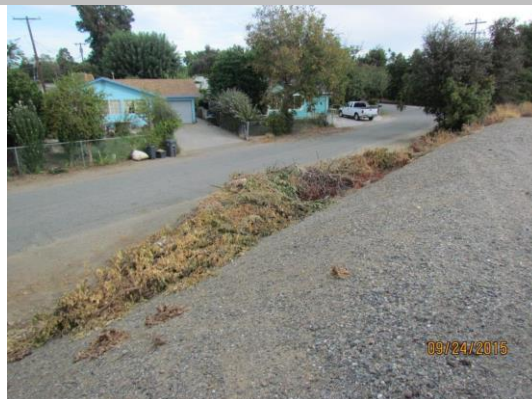
Photo 1 of 2 : FA_2016_NA0019_81_15_20160823_00008.jpg

LM Start	2.63	Rating **	M	Issue No.	15
LM End	2.63	Issue Type +	En	Location *	LS
Category	Earthen Levee			GPS Latitude/Longitude	
				Start	End
Item	Encroachments			40.054337 °	40.054337 °
				-122.144235 °	-122.144235 °
DWR ID	DWR_NA0019_04_s_2015_15				
Comment Code					
PR : Prunings					
Inspector Comment					
Remove the prunings from the landside toe.

View of the prunings along the landside toe.

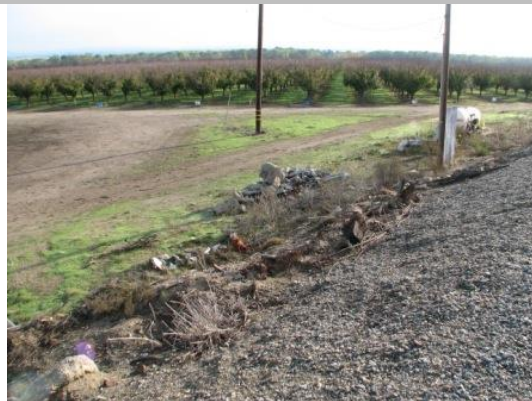
Photo 1 of 1 : FA_2016_NA0019_81_6_20160823_00004.jpg

LM Start	3.31	Rating **	M	Issue No.	6
LM End	3.31	Issue Type +	Ma	Location *	LS
Category	Earthen Levee			GPS Latitude/Longitude	
				Start	End
Item	Encroachments			40.057558 °	40.057558 °
				-122.134417 °	-122.134417 °
DWR ID	DWR_NA0019_04_s_2012_6				
Comment Code					
GA : Garbage					
Inspector Comment

View of the garbage and metal along the landside slope and toe of the levee.

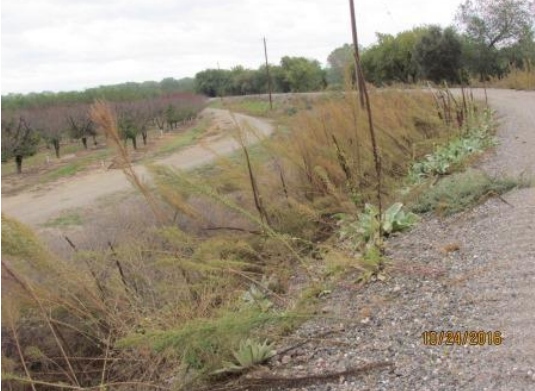
Photo 1 of 1 : FA_2016_NA0019_81_40_20161107_00038.jpg

View of the annual grass along the landside slope.

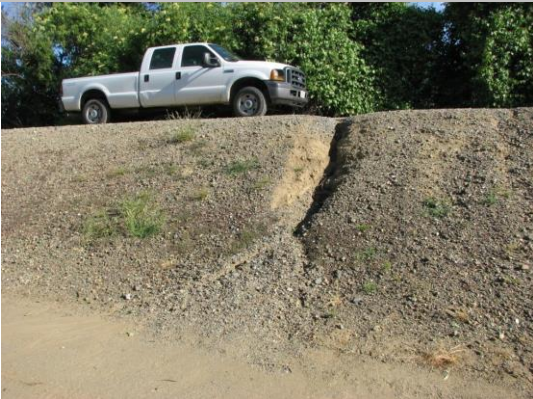
Photo 1 of 1 : FA_2016_NA0019_82_10_20160823_00004.jpg

View of the erosion along the landside slope.
